## Effect of Human Interventions on Hydro-Dynamics of Sidi-Abdel Rahman Bay “North Western Coast of Egypt”

Sidi Abdel Rahman is the most precious coastal zone in the Egyptian North Coast. It is suffering from severe erosion. It has a variety of Coastal structures, including jetties, groins, revetments, and breakwaters; they were built to prevent coastal erosion. The study area involves tourism villages, located in Sidi Abdel Rahman Bay, which were subjected to fast erosion that got accelerated from May/June 2020 onward. This erosion led to the loss of approximately 40 meters of beach sand from the northern part of some beaches that are obviously redeposited southward. This may have been triggered by a number (or combination) of factors including climate-induced sea-level rise, and/or human-induced changes to sediment supply to the coast. This study aims to assess the shoreline changes during the interval between (2003–2021) in the study area of Sidi Abdel Rahman area. Also to evaluate the impact of the constructions of Marceillia and Hacienda resorts and the prediction of their future position. To achieve the aim of the study; Digital Shoreline Analysis System software (DSAS) had

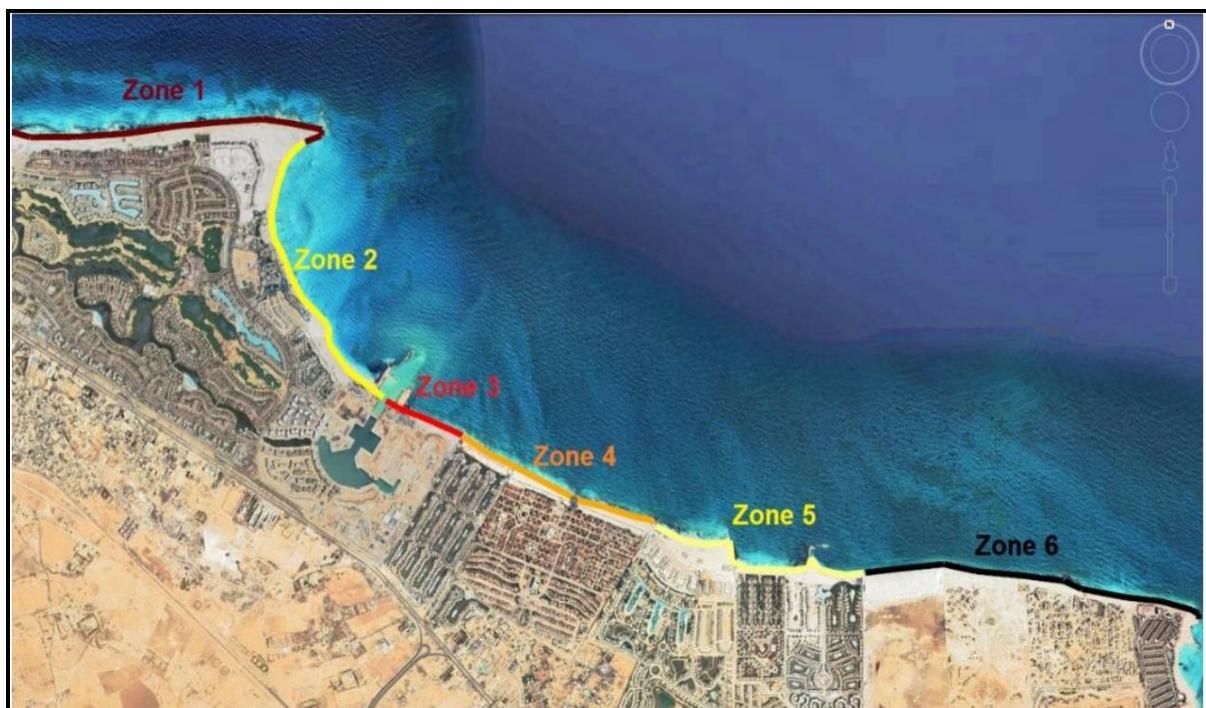
*Figure 2: Study area zones.*

The nature of the beach in the region has been divided into five sectors, according to its geological properties as follows: Figure 2

1. Marassi western rocky headland (zone 1).
2. Western sandy bay between Marassi headland and Marina (zone 2).
3. Limestone rocks at the eastern Marassi coast (zone 3).
4. Sandy soil mixed with limestone (Diplomats and Stella) (zone 4).
5. Sand mixed with limestone at Hacienda, Loaloe and Marceillia (4) coast (zone 5).
6. Rocky limestone Eastern headland (west of Lazourdi village) (zone 6).

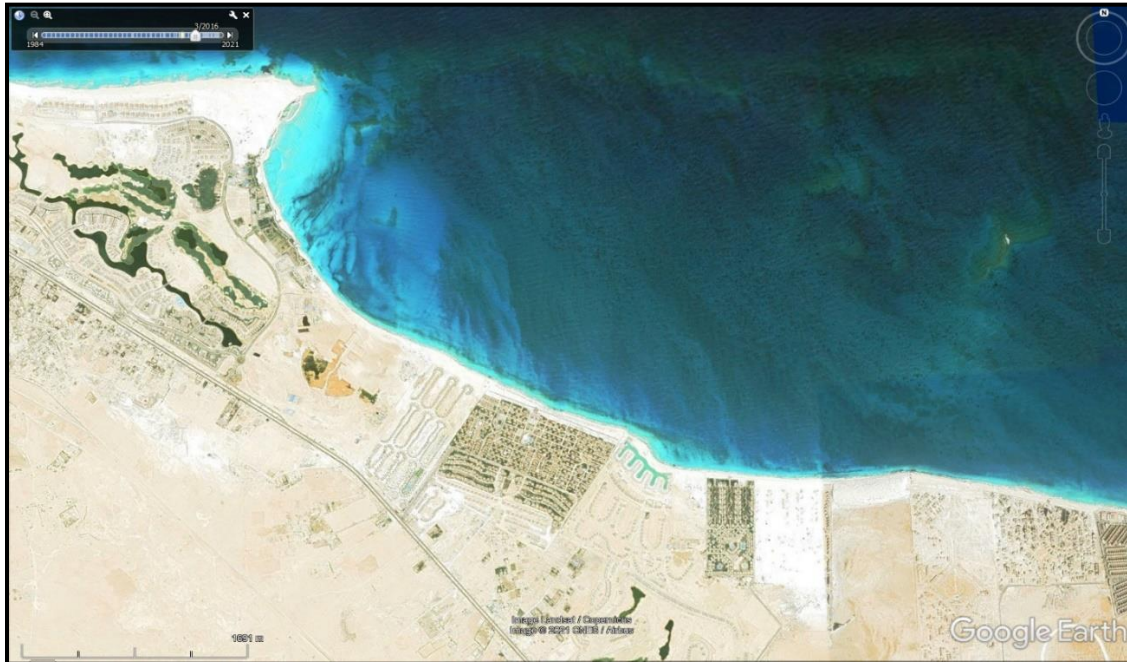
*Figure 3: The study area without any protection structures until October 2016 (Google Earth).*
